IR Scan Results

These images were taken on **8/9/2005** at **1:00:12 PM**

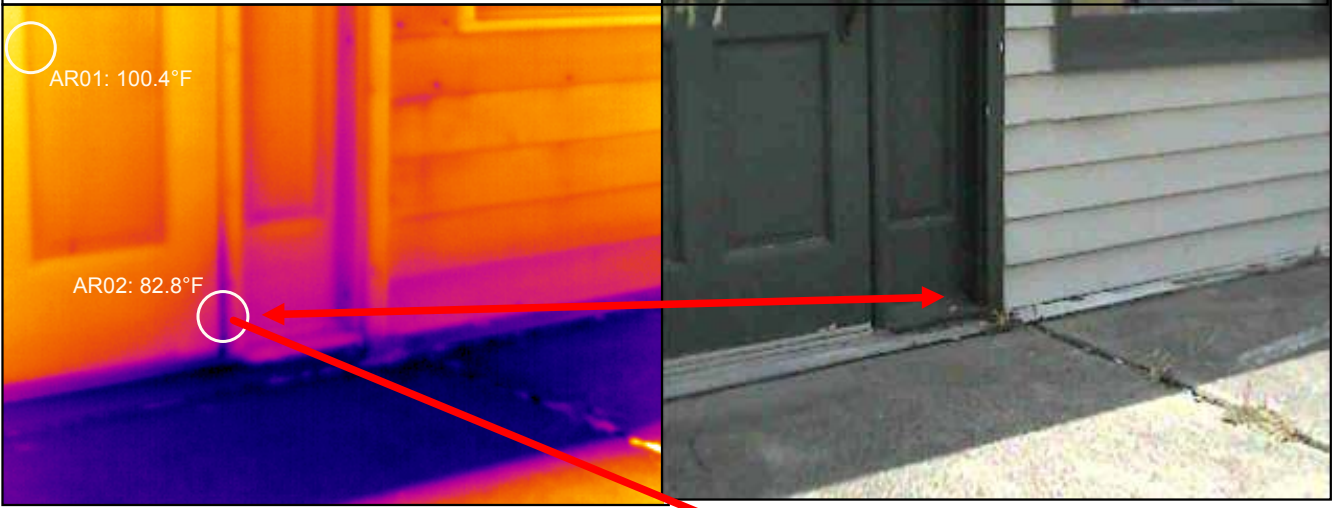
File Name	Pic029.jpg
-----------	------------

Infrared Image Information	Ambient Temperature	-
Temperature Rise (AR01 - AR02)		10.5 °F
Reference Temperature (AR02)		90.0°F
Point of Concern Temp. (AR01)		100.4°F

<u>Infrared Image Information</u>	
Location	Front Entrance
Problem	Moisture Saturation
Condition	Serious
Comments	May cause Rotting

Unprotected dry wood often wicks water like an oil lamp wicks oil
