IR Scan Results

These images were taken on **11/1/2005** at **6:26:59 PM**

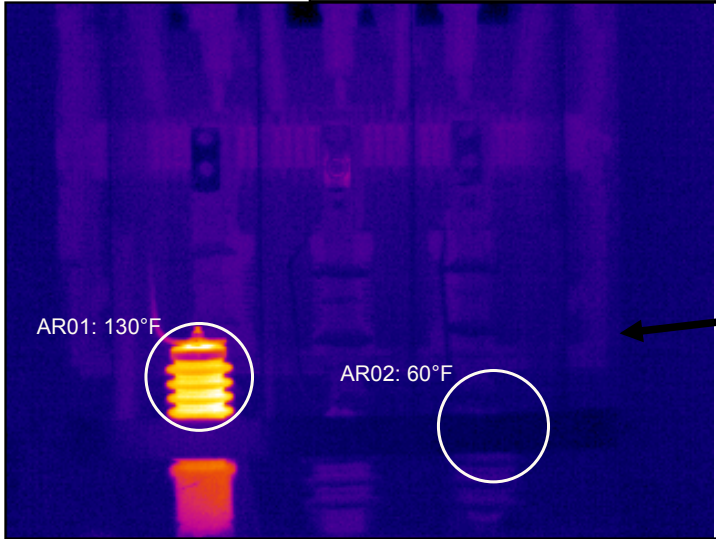
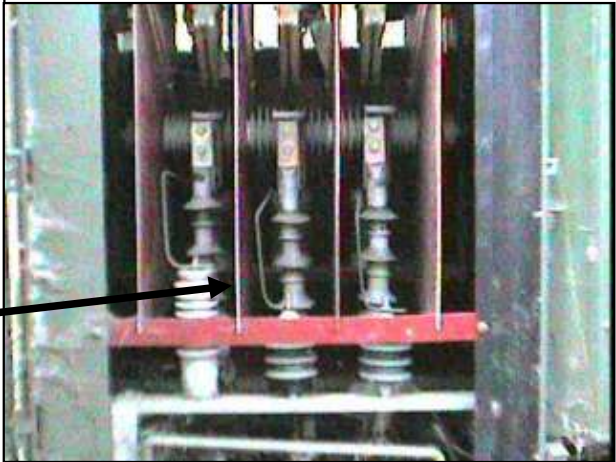
File Name	lr_0170.jpg
------------------	-------------

Temperature Rise (AR01 - AR02)	60.9 °F
Reference Temperature (AR02)	69°F
Point of Concern Temp. (AR01)	130°F

Location	2
Problem	MOV arrester
Severity	Critical
Comment's

Improperly torqued connections is the major cause of these type problems. Few bother to check the manufacturing specifications on new equipment. The results from these failures often range from personal injury to costly physical damage at the least
