## IR Scan Results

These images were taken on **11/9/2005** at **10:29:14 AM**

File Name | Ir\_0186.jpg

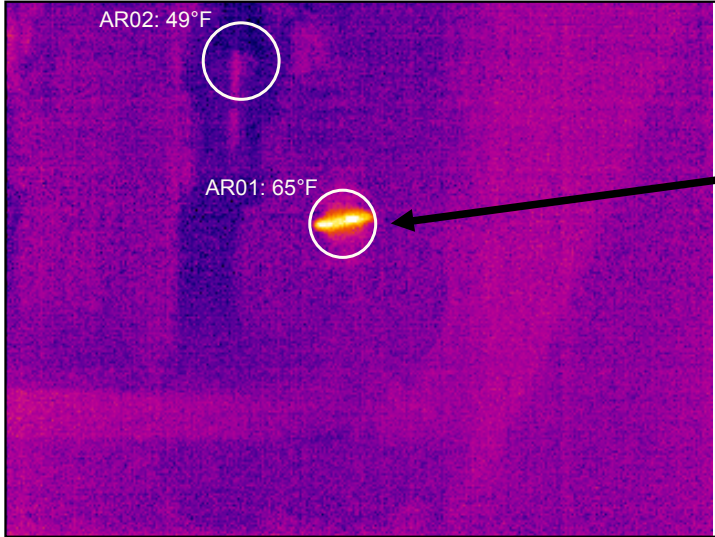
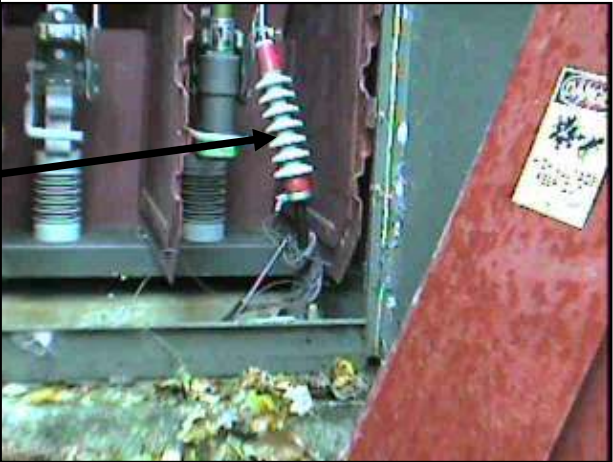
<b>Temperature Rise ( AR01 - AR02)</b>	<b>11.2 °F</b>
<b>Reference Temperature (AR02)</b>	54°F
<b>Point of Concern Temp. (AR01)</b>	65°F

<b>Location</b>	2
<b>Problem</b>	Improperly installed U.G. Terminator
<b>Severity</b>	Critical
<b>Comment's</b>

Failed Underground Terminators are often excessive when it comes to time and labor paid to correct . Not to mention customer dissatisfaction . Quality and Reliability are Hugh in todaysUtility Industry.
