## IR Scan Results

These images were taken on **8/9/2005** at **1:04:15 PM**

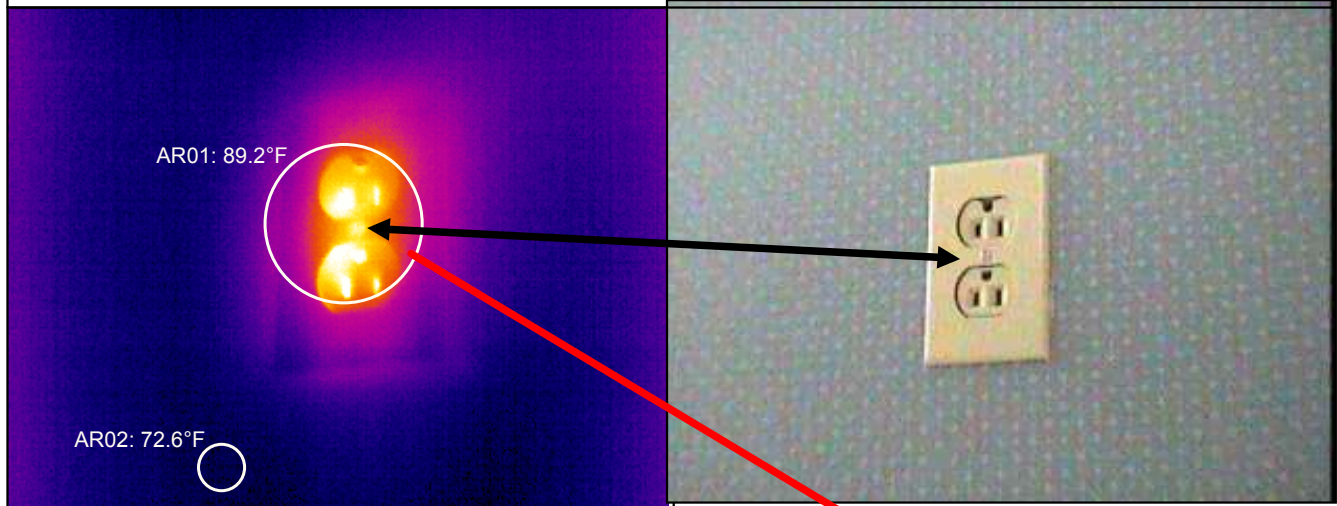
File Name: **Pic033.jpg**

<b><u>Infrared Image Information</u></b>	<b>Ambient Temperature</b> -
<b>Temperature Rise ( AR01 - AR02)</b>	<b>15.7 °F</b>
<b>Reference Temperature (AR02)</b>	73.4°F
<b>Point of Concern Temp. (AR01)</b>	89.2°F

<b><u>Infrared Image Information</u></b>	
<b>Location</b>	Upstairs Bedroom
<b>Problem</b>	premature wall outlet failure
<b>Condition</b>	Critical
<b>Comments</b>	Electrical problem

*Electrical problems range from minor to Fatal if ignored . With an anomaly of only 15.7 degrees this is a very serious problem*
