## IR Scan Results

These images were taken on **8/9/2005** at **1:13:39 PM**

File Name Pic045.jpg

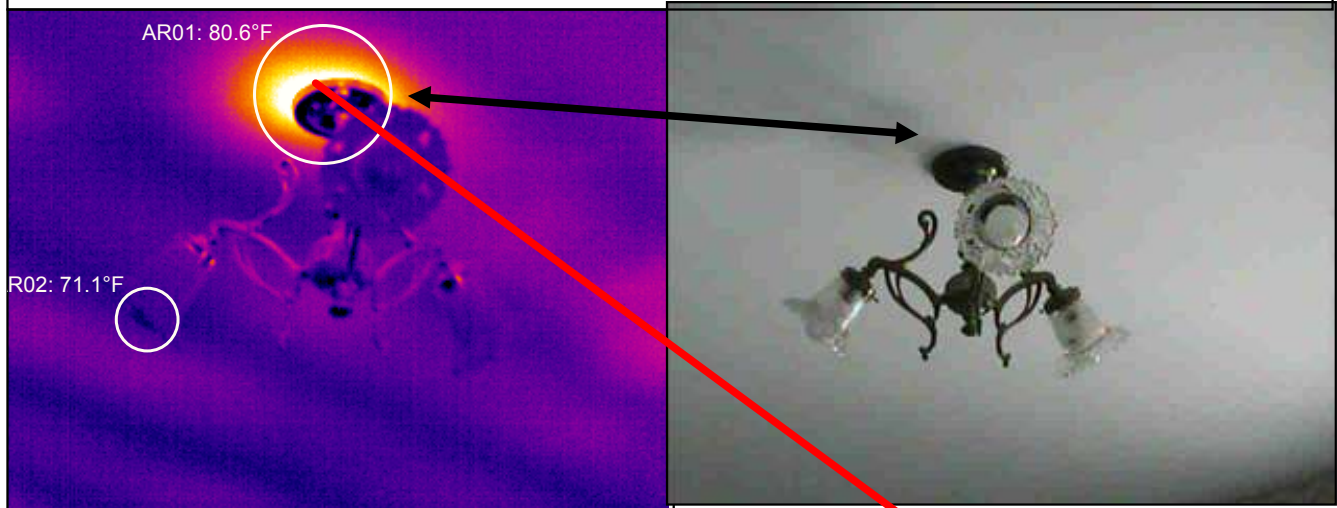
<u>Infrared Image Information</u>	<b>Ambient Temperature</b>
<b>Temperature Rise ( AR01 - AR02)</b>	<b>7.9 °F</b>
<b>Reference Temperature (AR02)</b>	72.7°F
<b>Point of Concern Temp. (AR01)</b>	80.6°F

<u>Infrared Image Information</u>	
<b>Location</b>	1
<b>Problem</b>	Insulation
<b>Condition</b>	Minor
<b>Comments</b>	minor corrections

Insulation was disturbed during fixtuer replacement . Over an extended period of time can be a very costly problem when the solution is only penny's
