IR Scan Results

File Name | Ir_0135.jpg

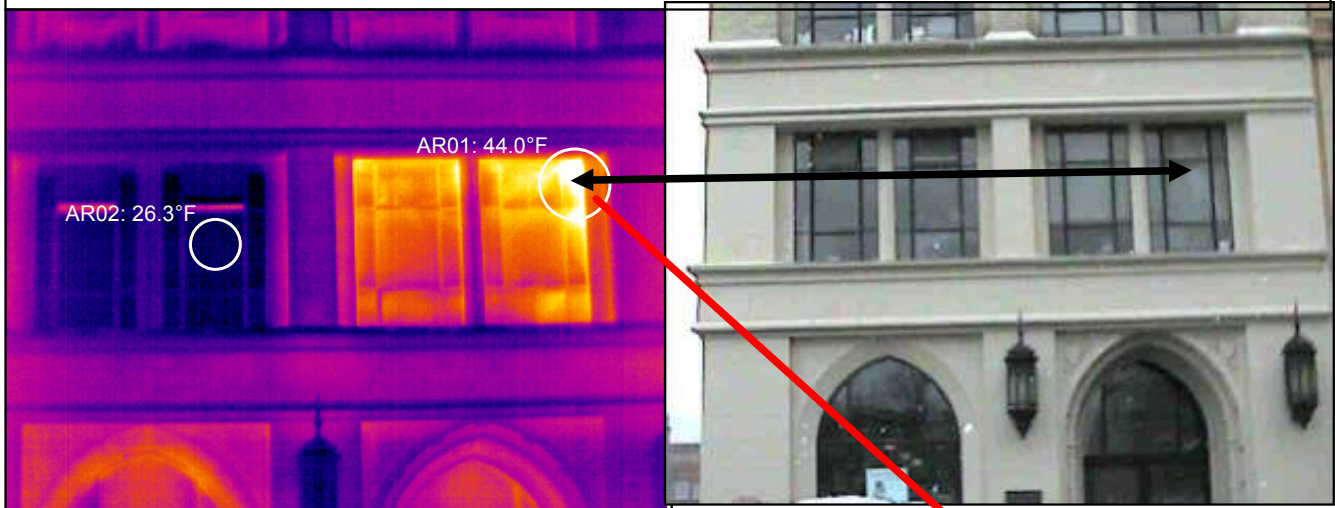
<u>Infrared Image Information</u>	Ambient Temperature
Temperature Rise (AR01 - AR02)	16.4 °F
Reference Temperature (AR02)	27.5°F
Point of Concern Temp. (AR01)	44.0°F

<u>Infrared Image Information</u>	
Location	Front Windows
Problem	Loss of Vacume Seal
Condition	Minor
Comments	Windows should be replaced

Loss of Vacume seal on thermalpayne glass. Undetectable to the eye
