FACE LIFT AT ST.PETERS CATHEDRAL

By Lisa West, ITC International Manager

FOCUS ON APPLICATIONS - SUPERMARKETS IN A DEEP FREEZE?

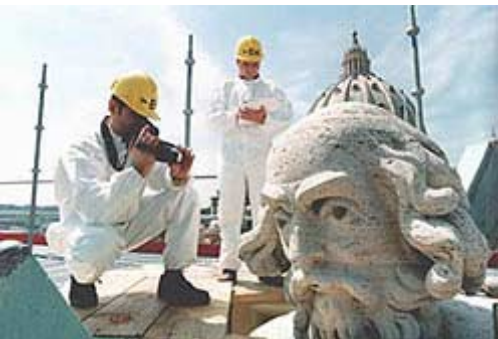
Their thermographic techniques proved to be very effective to diagnose the state of the monument before the restoration, and to verify the quality of the actual restoration effort. The team from EniTechnologie was able to identify cracks, detachments of stucco from the stone surface and deposits of humidity that would otherwise remain hidden. The most significant use of thermography was in evaluation of the stuccos where differentials of 0.5°C were determined to be the critical threshold. Thermography allowed the team to control and guarantee the state of approximately 50,000 stuccos on the Façade of the Basilica.

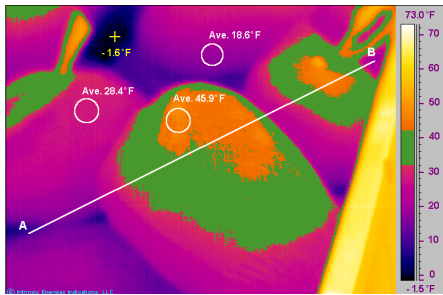
Thawed turkey in the "frozen" food case

and some showed serious problems. One of these was thawed turkey in an overstuffed, open-top freezer. A meat handler wanted to give an impression of "Plenty" by having a large supply of turkeys on hand in that freezer. You can see the insidious result in one of the images shown here. Imagine someone grabbing that thawed turkey, placing it in a hot car for a while before finally taking it home. There they might place it into a freezer for at least a month or more before using it.

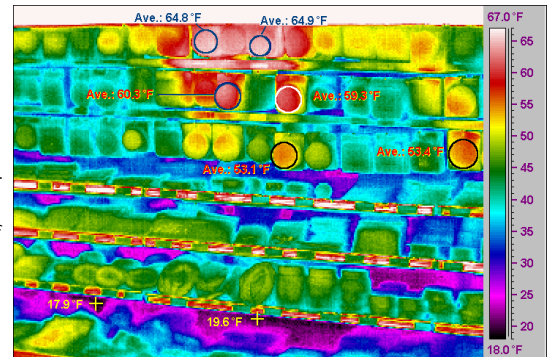
Warm packaged meats in the "refrigerated" case

Last winter I thought, "Why not take the 570 into a grocery store and examine the refrigerated food?" I found a willing grocer and took a look around. A whole new world opened up in the way thermal anomalies popped out in front of me. Distinct warm spots in refrigerated cases displaying raw meats, cheeses, processed meats manifested themselves. That night I saved more than twenty images,

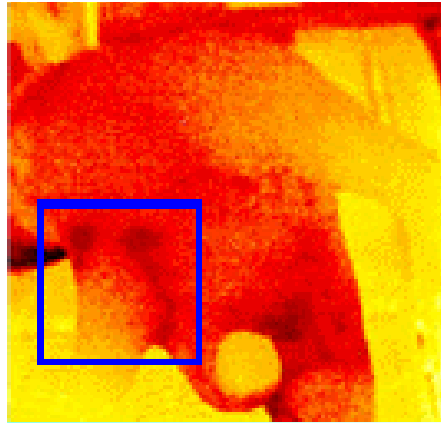
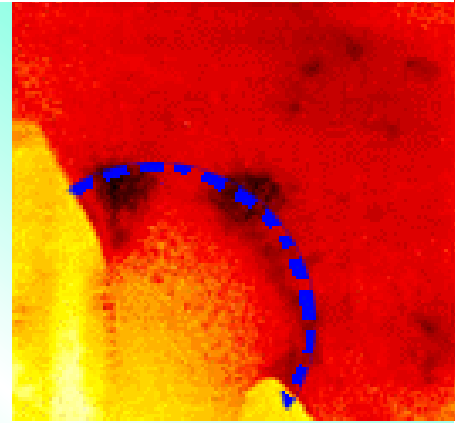
These thermal images are of the left hand of one of the statues. The temperature within the map varies from 11.7° to 16 °C . The coldest zones (the darkest areas of the map) correspond to the lesions that were repaired with stucco during the 1985-86 restoration (see the detail of the base of the pinky finger). The thermal image shows that the stucco is in a state of detachment from the surface of the stone, with the consequent creation of a humidity deposit in the area where the stucco meets the stone substrate. The other cold areas (from the palm to the wrist) are also rich in humidity. In this case, however, the cause is not restoration but rather the presence of colonies of micro-organisms.

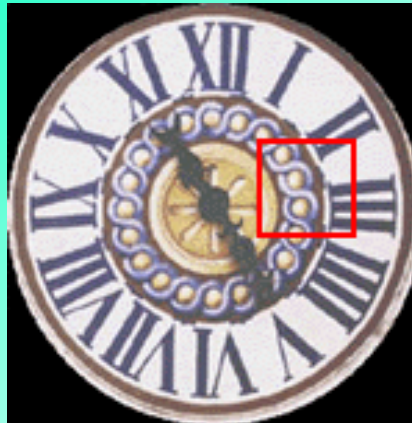
Thermography was also used to evaluate the state of preservation of the individual components of the mosaics in the two clocks located on the two extremes of the facade. The thermogram presented in above shows a portion of the "Oltromontano" clock mosaic (a surface of about 30 x 30 cm²). The temperature varies from 14.0° to 16.5° C. At the center of the thermal image, there are several sections that are markedly warmer, revealing a condition of thermal isolation from the substrate of the mosaic. Systematic analysis makes it possible to reconstruct a detailed map of the individual mosaic stones that are affected by this type of problem. The data gathered by the thermographic survey were supplemented with those gained from the high frequency (1.5 GHz) GPR surveys carried out on the same areas. These latter surveys provide structural details relative to depths of up to 50 cm.

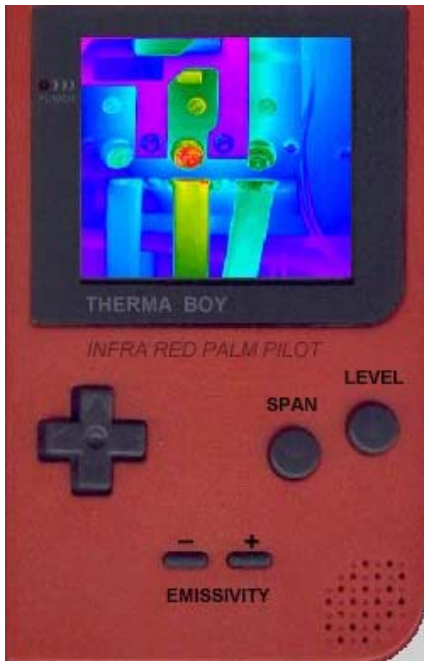
Therma Boy thermography system

Bernie's keen interest in science fiction as well as his electronics genius led him to develop the world famous Therma Boy shown on the next page! ♦
