## IR Scan Results

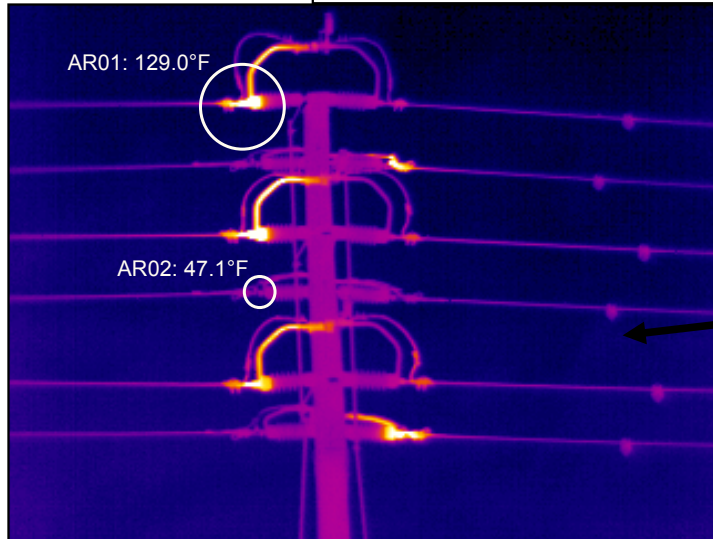
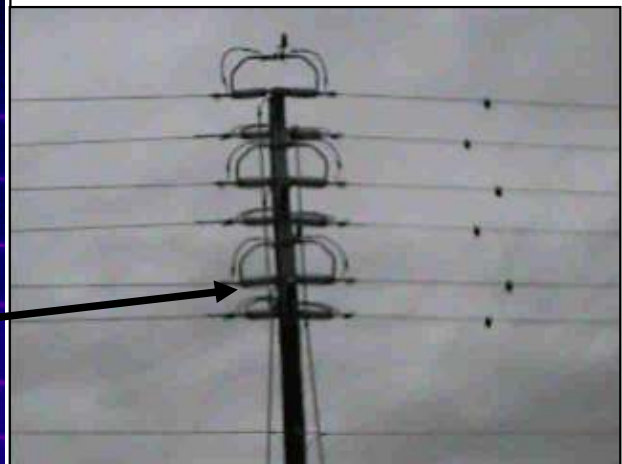
<b>File Name</b>	lr_0146.jpg
------------------	-------------

<b><u>Infrared Image Information</u></b>	<b>Ambient Temperature</b> -
<b>Temperature Rise ( AR01 - AR02)</b>	<b>74.5 °F</b>
<b>Reference Temperature (AR02)</b>	54.5°F
<b>Point of Concern Temp. (AR01)</b>	129.0°F

<b><u>Infrared Image Information</u></b>	
<b>Location</b>	2
<b>Problem</b>	Air Break switch connections failing
<b>Severity</b>	Critical
<b>Comment's</b>

Unexpected failure of this type equipment can be devastating to Hospitals , Manufacturing processes or critical customers
