IR Scan Results

These images were taken on **10/14/2005** at **9:06:43 AM**

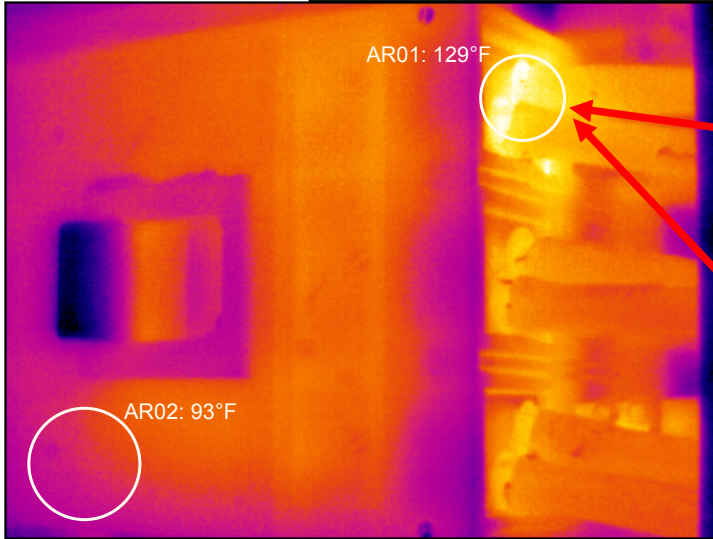
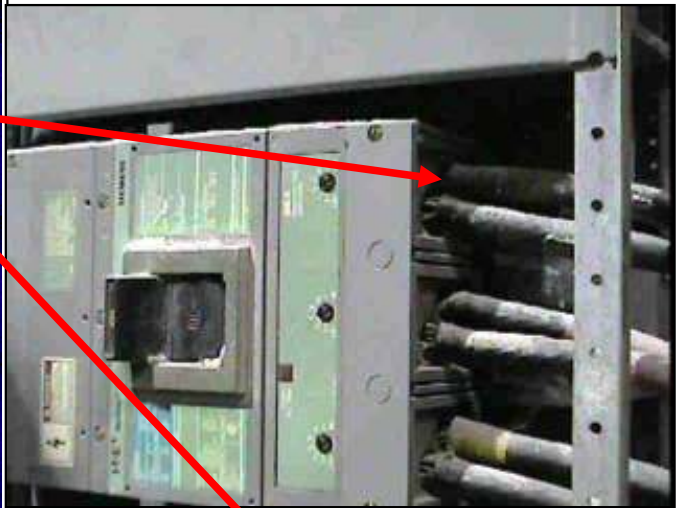
File Name | Ir_0112.jpg

<u>Infrared Image Information</u>	Ambient Temperature -
Temperature Rise (AR01 - AR02)	23.9 °F
Reference Temperature (AR02)	105°F
Point of Concern Temp. (AR01)	129°F

<u>Infrared Image Information</u>	
Location	Plant Main #1
Problem	Heating connection / 6000 switch gear
Severity	Critical
Comment's	None needed

For electrical equipment of this importance a 23.9 degrees anomaly is a very serious issue
