IR Scan Results

These images were taken on **11/8/2005** at **11:35:29 AM**

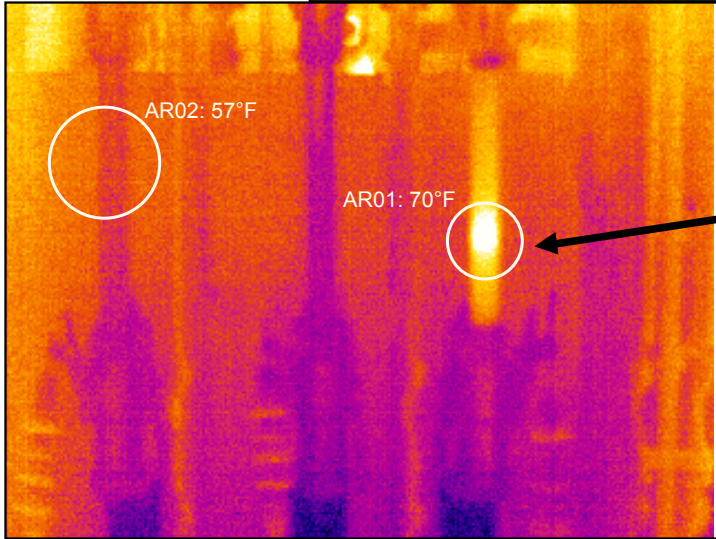
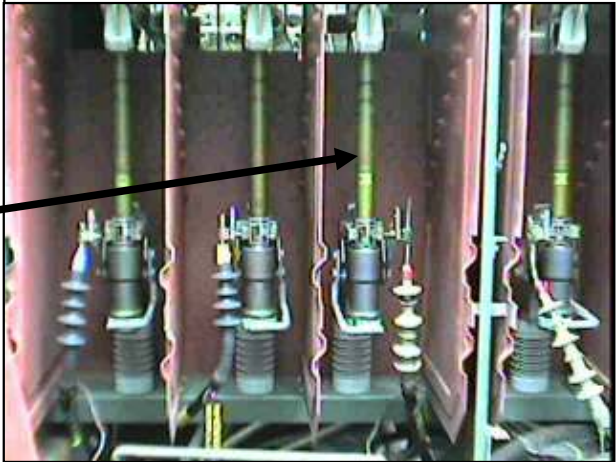
File Name | Ir_0178.jpg

<u>Infrared Image Information</u>	Ambient Temperature -
Temperature Rise (AR01 - AR02)	6.8 °F
Reference Temperature (AR02)	63°F
Point of Concern Temp. (AR01)	70°F

<u>Infrared Image Information</u>	
Location	Industrial Park anywhere
Problem	Improperly installed fuse
Severity	Critical
Comment's

These issues can be completely avoided with a good infrared predictive maintenance program and possible avoid numerous compensation claims
